PUBLIC WORKS COMMITTEE REPORT to the BOARD OF SUPERVISORS
Tuesday, January 25, 2022
8:00 a.m.
107 NORTH KENT STREET, SUITE 200, WINCHESTER, VIRGINIA

1-Discussion/Update on the sinkhole issue at Crystal Lake/Cherokee Dam – Shawneeland Sanitary District:

RE: Revision 1 - Report of Geophysical Investigation
[Crystal Lake Sinkhole Investigation \(Cherokee Dam\)](#)
152 Tomahawk Trail, Winchester, VA
VEPC Project No: PTL-212862

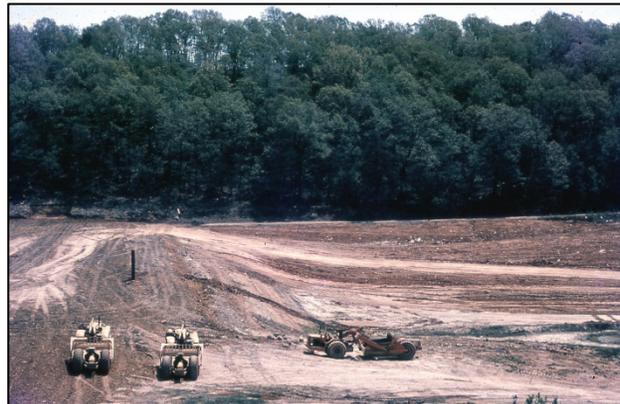
Figure 1. Dam Construction

Cherokee Dam is located perpendicular to the strike of bedrock underlain by various geological formations, several of which include soluble limestone. We understand the site and dam embankment is underlain by several geologic formations with limestone inclusions that are solution prone according to published maps, review of previous site study, and grouting program performed by Hayward Baker.

Based on a review of the grouting program, we summarize that grouting began in November 2008 and was terminated in April of 2009. A total of 33 borings were injected with grout to depths of 150 feet, as referenced from the top of the dam, with a cement grout/bentonite additive. Records indicate a total of 2097 cubic yards of grout was injected to develop a subsurface curtain that appeared to minimize water flow through subsurface voids at depth. However, it was stated some leakage is inevitable in this karst geology. We conclude that it is nearly impossible to effectively stop leakage in karst geology nor can any grouting plan guarantee similar future sinkhole development will not occur. However, targeted remediation can significantly reduce the likelihood of drainage through karst development and reduce subsurface drainage rates.

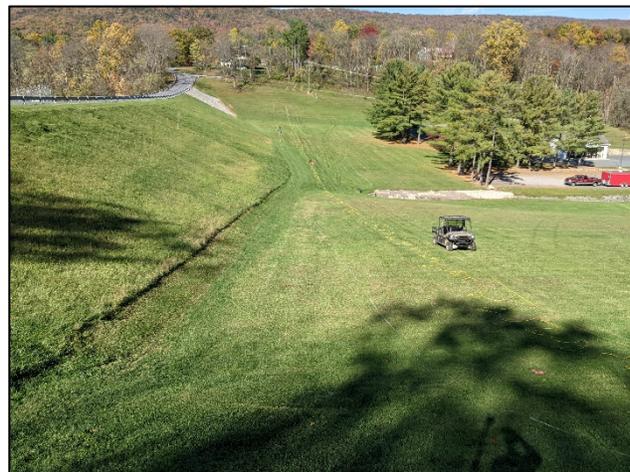
Figure 2. ERI Field Investigation

A three-dimensional ERI survey along [six \(6\) parallel lines](#) running east to west along the downstream slope and toe of Cherokee Dam. The study included a [dipole-dipole](#) array resistivity survey utilizing the Advanced Geosciences, Inc. (AGI) SuperSting R-8/IP Passive Earth Resistivity System. The ERI lines were spaced approximately 16 feet apart with a length of 664 feet each. The resistivity lines were established with an electrode spacing of 8 feet to gain a maximum resolution and imaging depth of approximately four (4) and 130 feet, respectively. Anomalous resistivity zones were mapped in an effort to identify flow paths which traverse the survey area to distinguish potential remediation areas. Further, resistivity imaging data was processed and inverted using AGI's proprietary 3-D resistivity inversion software, EarthImager 3-D, to generate the inverted resistivity sections. Terrain correction was performed utilizing high resolution elevation data obtained from USGS 3DEP one-meter Light Detection and Ranging (LiDAR) bare earth elevation maps. Electrodes were located in the field with multi-band RTK GNSS receivers with a nominal location accuracy of less than three (3) centimeters.

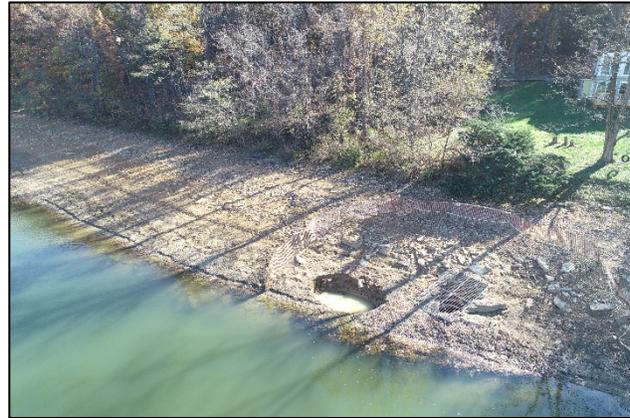
Figure 3. Sinkhole Development Along Shoreline

Resistivity imaging of the project site suggests variable moisture conditions beneath estimated top of bedrock likely indicated zones of water infiltration. Zones of higher resistive material likely represent competent bedrock while lower resistivity values were observed along the existing dam outfall barrel and buried piping (siphons). A discontinuous low resistivity zone is noted on all ERI sections along the eastern edge of the ERI data. This area is indicative of fractured bedrock harboring water flow. Further, it is believed the contact between dissimilar geologic formations is closer to the site than is mapped leading to accelerated bedrock degradation. A zone of probable remediation was identified along the eastern extents of the survey area as mapped on the attached Location Plan and Inverted Resistivity Sections. An area of low resistivity subsurface conditions was noted due west of the dam outfall pipe only in a handful of sections. It is believed this hydraulic feature is derived from water infiltration at the surface near the end of the outfall pipe.
