RE: Emergency Sinkhole Backfill Recommendations Crystal Lake at Shawneeland Subdivision Rosenberger Lane, Winchester, Virginia VEPC Project No. PTL-222909

Crystal Lake Sinkhole Emergency Backfill Recommendation Page 2

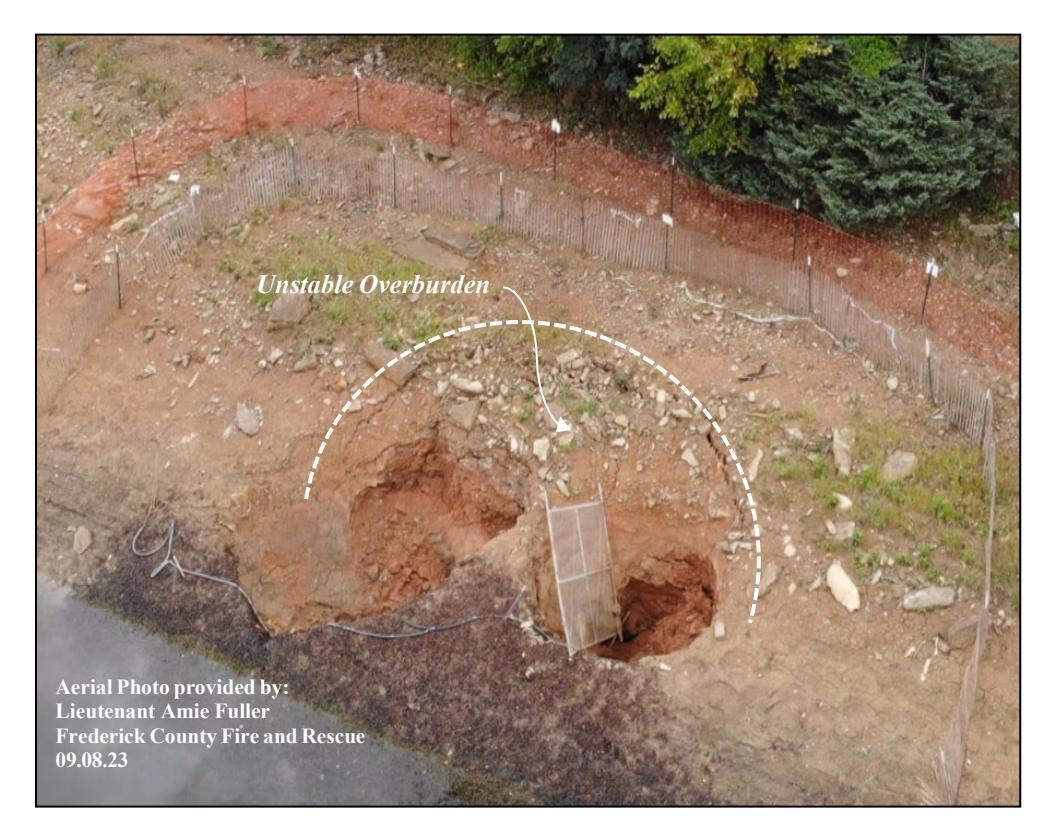
Due to the prolonged drought conditions over the past several months, the water level of Crystal Lake has dropped over 11 feet below the normal pool elevation. As a result, the two (2) apparent sinkholes located along the eastern shore have increased in the surface size caused by recent collapses; subsequently, making these features a public safety concern. Therefore, we suggest filling the sinkholes in an effective manner as soon as possible. Please note that our recommendation is to promote public safety and not to remedy the sinkhole problem at this time. Actual measurement of the sinkholes was not taken during our site visit conducted on September 8, 2023; however, an estimated combined area of the sinkholes is 30 x 40 feet and approximately 8 to 10 feet deep at the mean height of the bank relative to the current water elevation.

- Develop construction equipment access to the sinkhole area, remove existing fencing as necessary to import and place fill material in a safe manner.
- Excavate cracked portions of sidewalls to prevent excess amounts of material from falling inward during the filling process. Keep heavy construction equipment at least 8 feet from the sinkhole to prevent additional sidewall collapse.

- Place large boulders comparable to VDOT Class II riprap into the sinkholes and press into loose soils exposed at depth. Two lifts of boulders may be necessary to develop a suitable side wall support and foundation for additional fill material.

- Subsequently, place several feet of VDOT #1 stone (or comparable) as needed to effectively choke out voids in the underlying Class II riprap.
- Backfill to grade with dirty tailings typically available from nearby quarry in 12-inch lifts after firmly tracking to consolidate.

- Continue placing and consolidating lifts to grade and shape surface contour to meet existing bank slope.
- Fence out this area upon completion and post warnings accordingly.

As mentioned, this backfill procedure is intended to promote public safety as soon as possible and does not serve to seal the sinkhole feature(s). Therefore, routine maintenance will be required as future pipes or internal erosion occurs. A plan to cap the area can be developed after the underlying karst feature is effectively sealed.
